| | | Performance report for SiT9365, 122.88 MHz, HCSL | | |
|---|---|--|---|---|
| S ¹ Time | Type: | Performance report | Rev: | 1.0 |

Performance report for SiT9365 - 122.88 MHz, HCSL

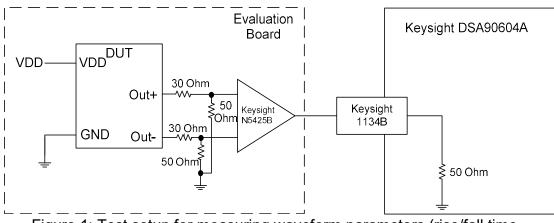
For waveform parameters measurement (rise/fall time, differential swing, duty cycle), both DUT outputs are terminated with 30 Ω series and 50 Ω to GND. Output signals are measured using Keysight 1134B active probe with Keysight N5425B probe head. All measurements are applied to the differential waveform. Figure 1 shows test setup diagram for waveform parameters measurement.

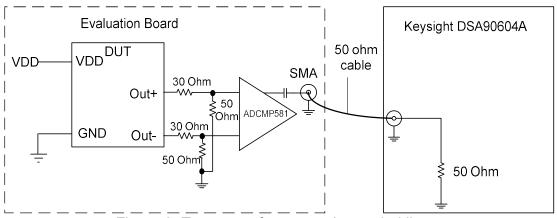
For period jitter measurement output is terminated with 30 Ω series and 50 Ω to GND at the input of hi-speed comparator (ADCMP581). AC coupled comparator's output is connected to oscilloscope channel. Figure 2 shows test setup diagram for period jitter measurement.

Figure 2: Test setup for measuring period jitter

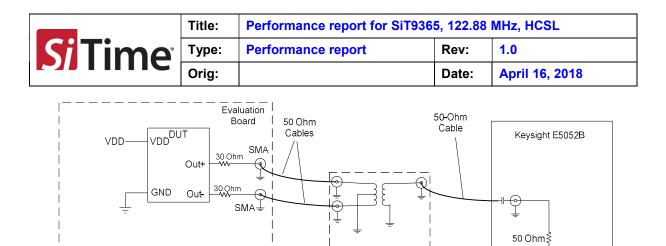
For phase noise measurements, differential signal is converted to single-ended using impedance matching transformer. Transformer's output is connected to measurement instrument. Output is also terminated with 30 Ω series at the source side. Figure 3 shows test setup diagram for phase noise measurement.

Figure 3: Test setup for measuring phase noise.

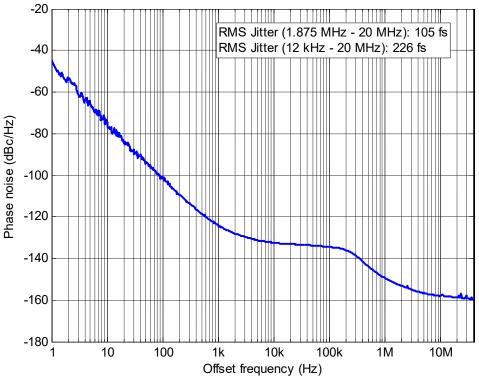
Figure 4: Phase noise, 2.5 V

| Parameter | | Voltage | |
|--|---|---|---|
| Integrated Phase jitter (1.875 MHz - 20 MHz) | fs, rms | 105 | 104 |
| Integrated Phase jitter (12 kHz - 20 MHz) | fs, rms | 226 | 225 |

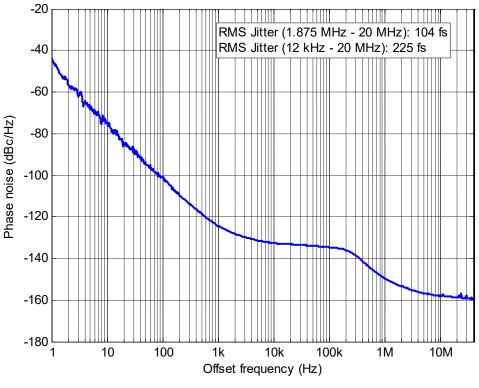
Figure 5: Phase noise, 3.3 V

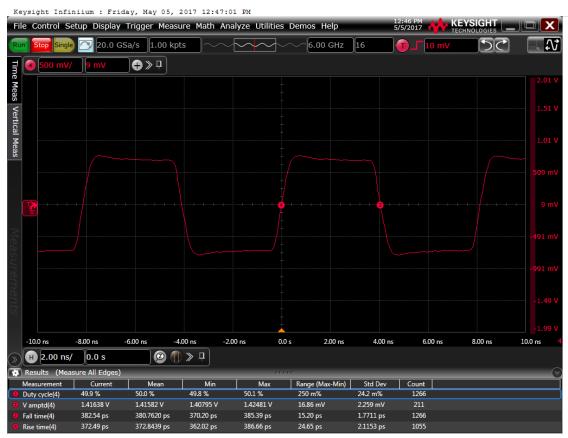
Figure 6: Output waveform, 2.5 V

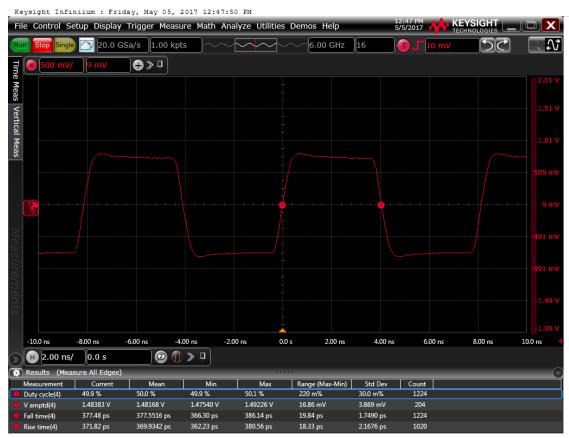
Figure 7: Output waveform, 3.3 V

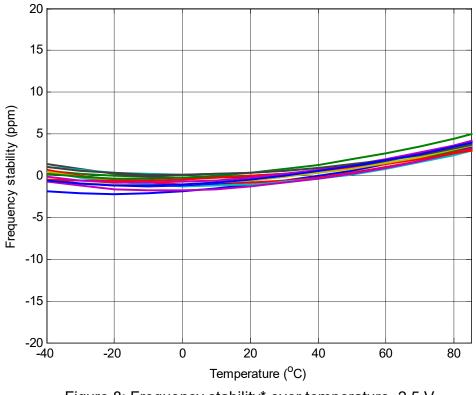
*SiT9365 frequency stability is independent of output frequency.

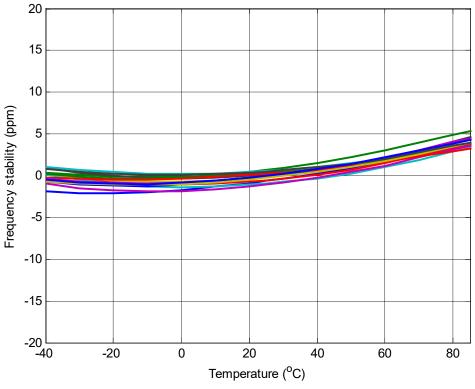
Figure 9: Frequency stability over temperature, 3.3 V
